# PROPERTY SUMMARY REPORT

## 3600 Hacienda Blvd, Davie, FL

Property Address: 3600 Hacienda Blvd, Davie, FL 33314

**Date of Inspection**: 04/02/2025 **Roof Type**: Fibertite Single Ply **Roof Installation Year**: 2011

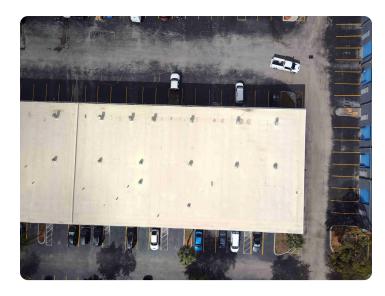
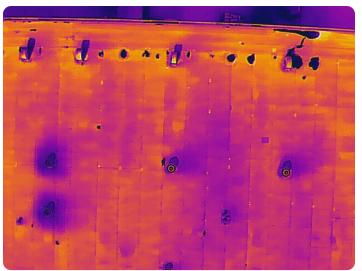
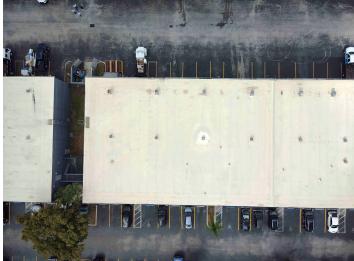
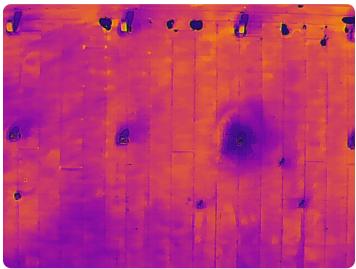
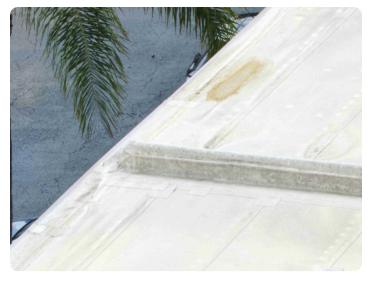
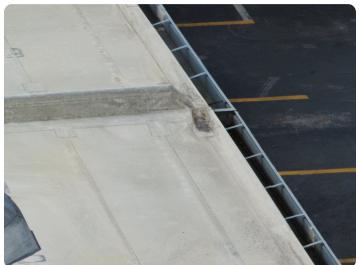
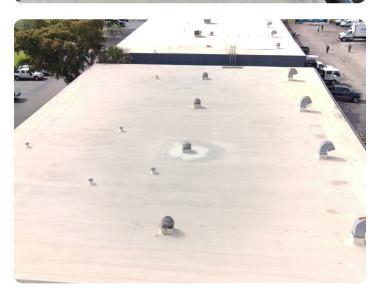
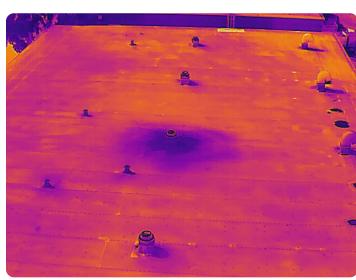
No immediate structural concerns visible from the exterior. No patch work and/or roof debris observed. Roof in good condition.

Little to no thermal anomalies detected. Moderate cool spots were observed near areas with visible dirt buildup roof surface. Consistent shading in thermal variances indicate a healthy roof structure.
